Museum in midst of facelift

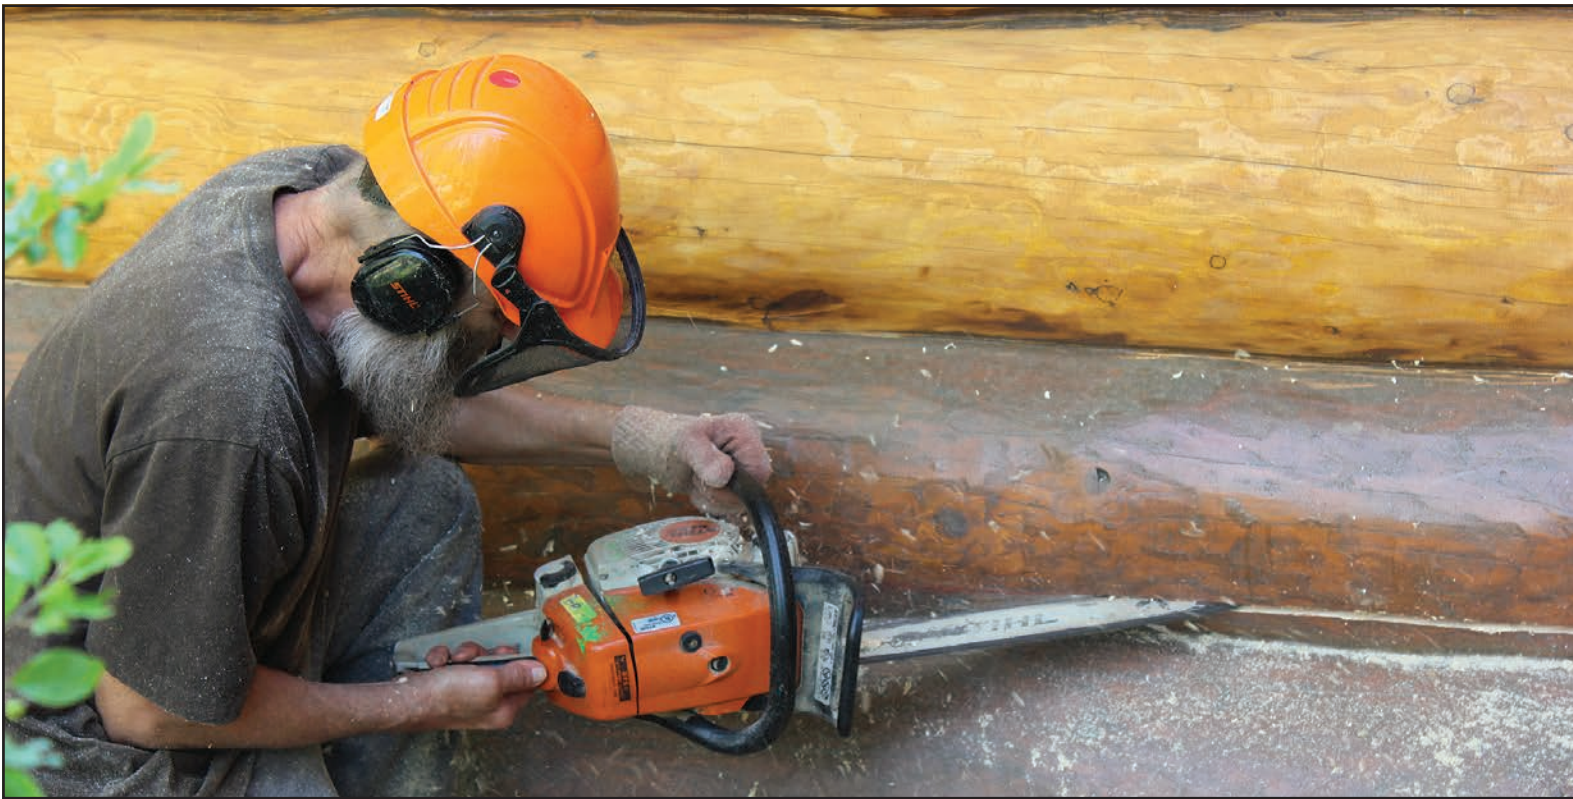
Carpenter Len Friesen cuts the rotten part of a log out of the Heritage North Museum so a new slab can be put into its place.

Friesen says the rot in the wood goes in about three or four inches, so the workers are using chainsaws and other tools to cut away the rot. "I'm making a slab with the logs that are out there, which is flat on one side, and a log profile

Friesen noted that there were two other problems that have caused this amount of rot. The museum does not have a big enough overhang on the roof, so the rain is hitting the logs too often, as well as the logs weren't getting the proper annual sealing spray.

There were two options when it came to replacing the rotten logs at the heritage site. The first one was to replace the full log, but the carpenter believed that would be too costly, so they went with option two. The carpenter and his two casual employees are carving out the rotten part of the logs, and replacing them with new spruce log slabs.

To fix this problem the southern workers are grounding all the old finish off the current logs, and spraying on a wood preservative, which will seal the logs. After it's sprayed the logs are then refinished, and Friesen says the logs should now be sprayed annually to eliminate future rot.

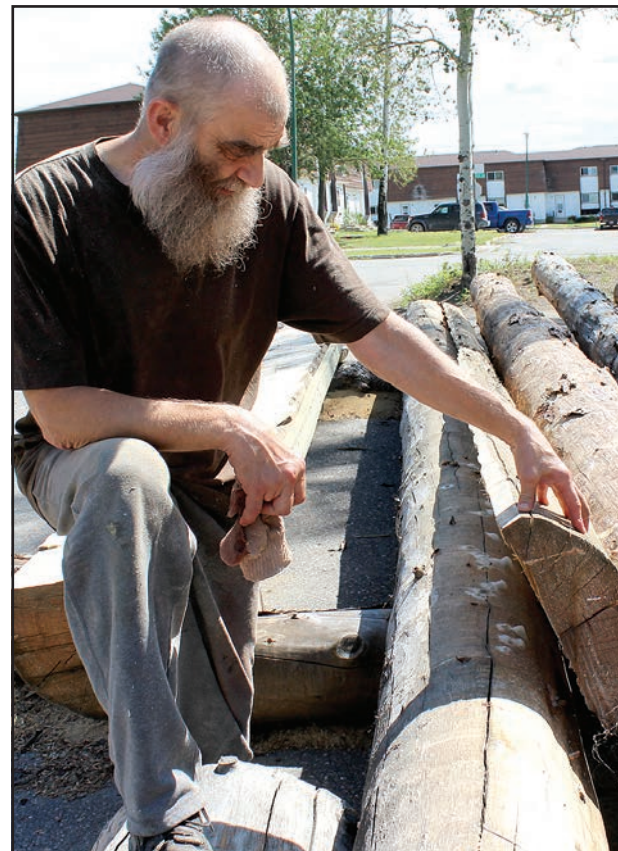
on the outside, and then we're fitting it into place."

Friesen shows what slabs will look like for the log replacement project at the Heritage North Museum.
